The State Oil Company of Azerbaijan Republic

- Markets: Industry & Manufacturing
- Country: Azerbaijan
- Courtesy of: CST & SUPERIOR PRODUCTS EUROPE

PROJECT DESCRIPTION

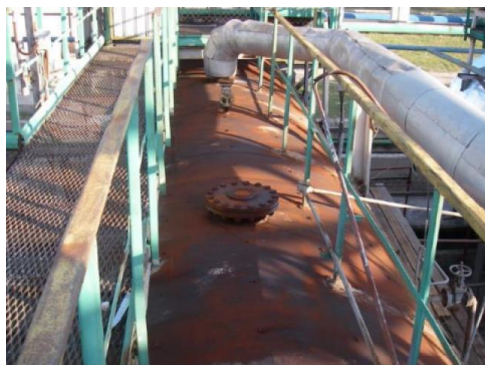
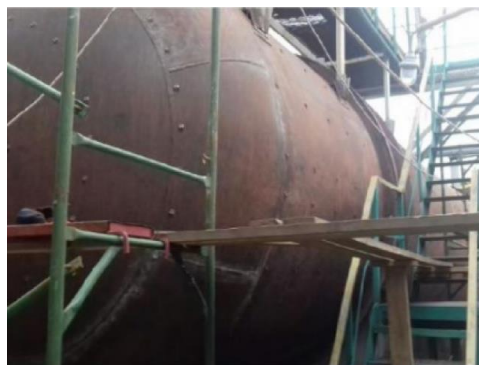
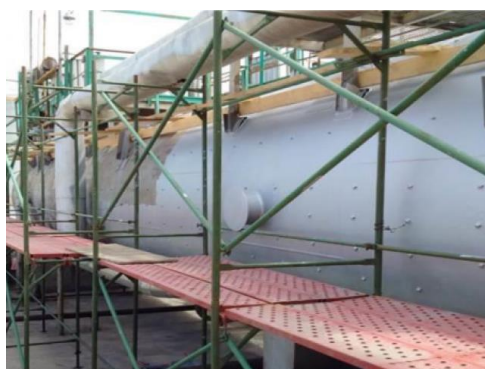
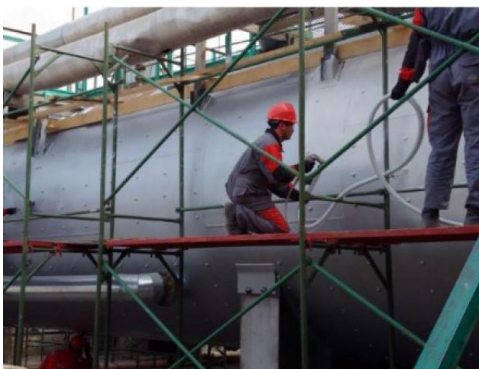
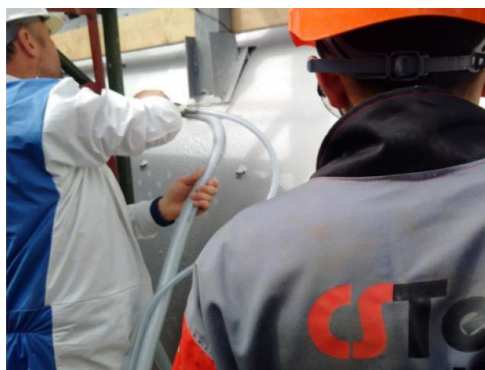
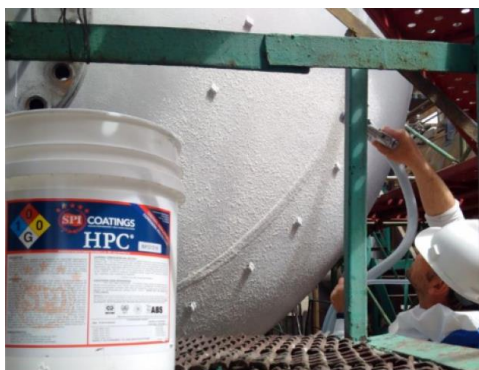
An Oil Separator suffered from C.U.I and customer needed to replace insulation and prevent further damage. In addition they looking to save energy and give personal protection. The tank surface temperature is +/- 150°C and is located outside in heavy industrial area.

Old cladding and fiber insulation were removed and loose corrosion hand tool cleaned. 2 heavy coats (125 – 150 μ WFT) **RUST GRIP®** were applied. 1st coat to encapsulate remaining corrosion and 2nd also to glue 1st thin coat **HOT PIPE COATING™**. Consequently, the next layers were build up till the desired thickness of 12 mm **HOT PIPE COATING™** was achieved. Finally, for sealing and weathering protection, **ENDUROOF** in 2 different layers was applied.
