INDUSTRIAL MANUFACTURER – AUTOMOTIVE

TRELLEBORG VIBRACOUSTIC

PROJECT DESCRIPTION

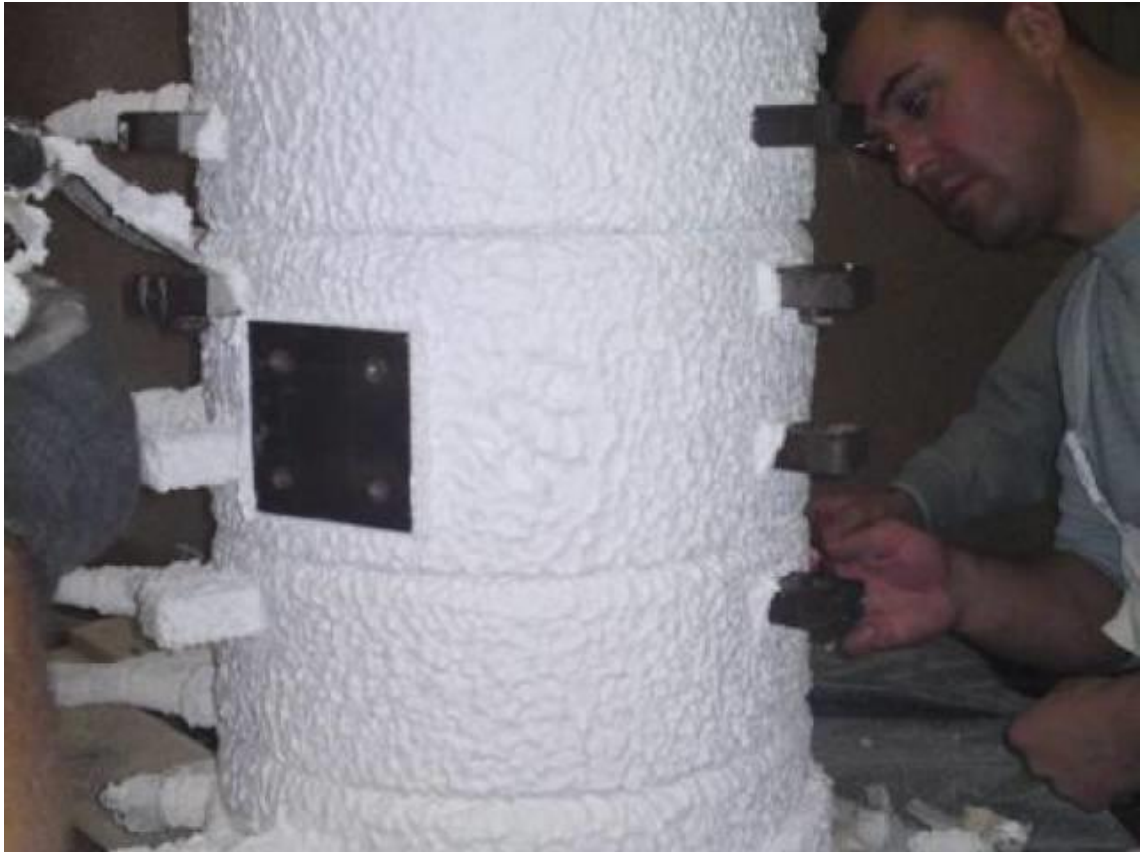
The inside temperature during vulcanization in this mold is 175°C.
Problem is that the outside temperature is +/- 165°C, creating a high safety risk and energy losses by radiation.

7mm Hot Surface Coating was applied with a spray gun on the outside.

Outside temperature dropped to 63°C.
