**MULTINATIONAL DIGITAL IMAGING PRODUCER**

**PROJECT DESCRIPTION**

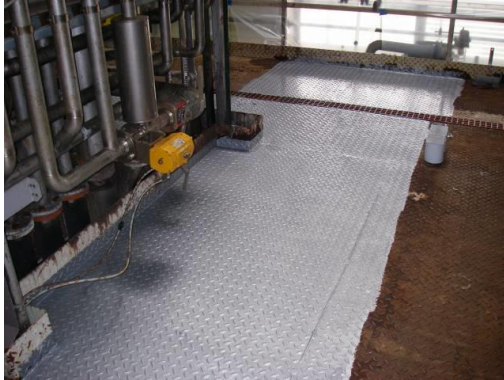
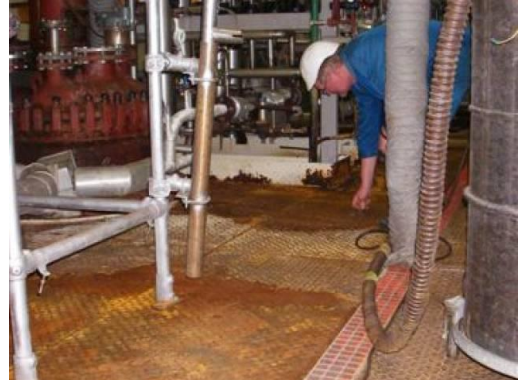
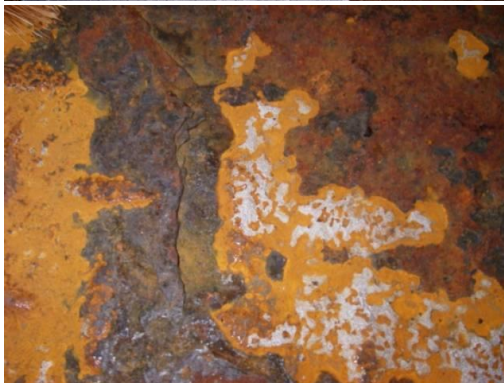
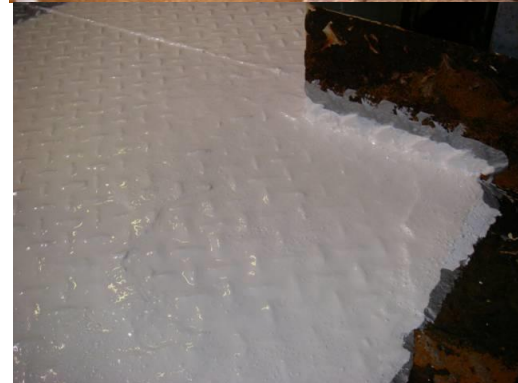
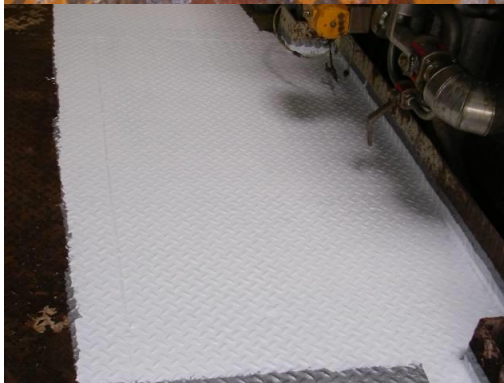
Treatment of metal slabs in EX-zone production department. Due to high acid levels in aggressive environment, the metal was rapidly deteriorating. Welding was not possible due to explosion hazard.

In the floor plates, different holes were present due to extensive corrosion.

Treatment consisted of manually removing loose pieces of rust. Next step was to apply 2 layers of RUST GRIP with a roller. After drying, by while RUST GRIP is still wet, 2 layers of ENAMO GRIP were applied.

It has been confirmed that this was the only long-term solution that proved to be sustainable, however, since the completion of the project there has been an internal decision to use stainless steel plates in the future.
